Re: Policy Number: 3954484
Insurance Company: Economical

Property Inspection Report

! Insured Name:	BARRY AND DEBORAH FRIEDMAN		
! Address Inspected:	1037 OAK LANE SOUTH SHARBOT LAKE, ON K0H 2P0		
! Policy # or Binder #:	3954484	! Insurer:	Economical Insurance
! Broker Name:	CARLETON INSURANCE BROKERS	! Broker Number:	57501
! Interviewed:	Barry Friedman		
! Date Inspected:	05/05/2012		
! Inspected By:	Doug Smyth	! Office:	Ottawa Click to find Office
! Current Coverage:	202000		
! Revised Coverage:	279743		
! Variance:	38.49%		
High Value:	<input type="radio"/> Yes <input checked="" type="radio"/> No Change Value

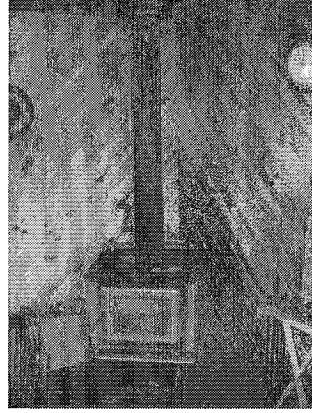
Type: Woodstove
Fuel: Wood
Year of Manufacture: Unknown
Condition: See Comments
Comments: The installation of the Pacific Energy Super Series woodstove located on the main level appears to meet all code installation requirements.

Main Level Woodstove

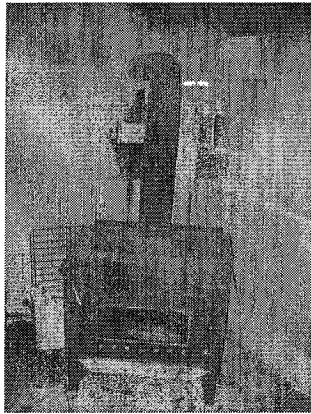
Type: Woodstove
Fuel: Wood
Year of Manufacture: Unknown
Condition: See Comments
Comments: The installation of the Haughs S-170 woodstove located in the basement appears to meet all code installation requirements.
Comments:

Basement Woodstove

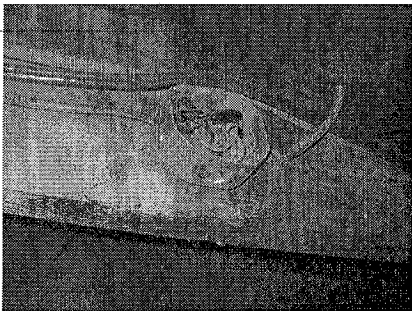
Missing Cover Plate

Some junction box cover plates are missing and should be replaced in order to reduce the risk of personal injury from electrical shock. - Code: E11

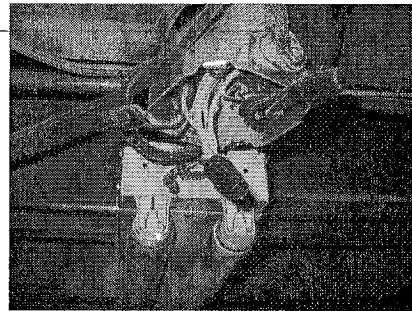
Missing Cover Plate

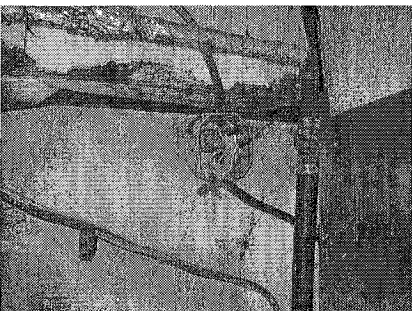
Loose Junction Box
& Missing Cover Plate

Loose electrical wiring noted in risk. In the interest of safety wiring should be properly secured in accordance with the electrical code. - Code: E16

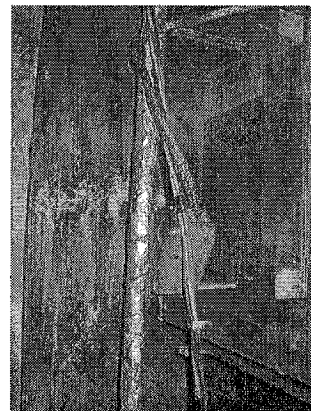
Loose Junction Box

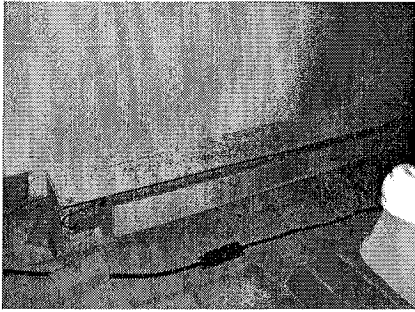
! Type: Electric Baseboards
! Fuel: Electricity
! Year of Manufacture: 1987
! Condition: See Comments
! Comments: The electric baseboard heater located in the finished basement area is not secured to the wall.

**Loose Electric
Baseboard Heater**

The electric baseboard heater located in the finished basement area must be properly secured to the wall.

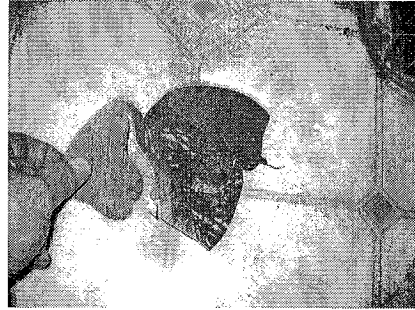
- ~ The subfloor located in the finished basement appears to be rotted in certain areas. Moisture was noted in the basement area along with a musty smell at the time of the inspection.
-

**Damp & Appears
Rotted Sub Floor In Finished Basement Area.
Varies Areas Of The Floor Are Soft & Punkie**

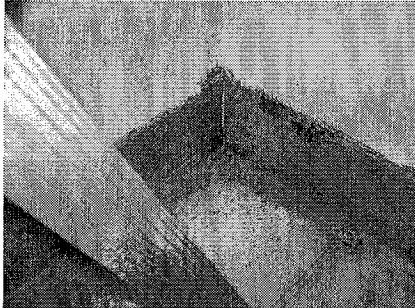
- ~ At the time of the inspection mould was reported by the tenant and noted. The mould was found to be located in the finished basement area of the home.
- ~ A dead & rotted tree with a significant lean towards the rear roof of the home was noted at the time of the inspection. The tree must be removed to prevent any physical accident that may occur to bystanders and also to prevent any damage that may occur to the rear roof of the home..

Mould

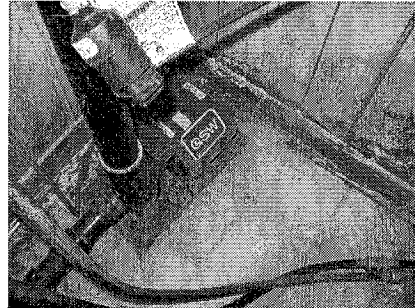
Damp & Mould

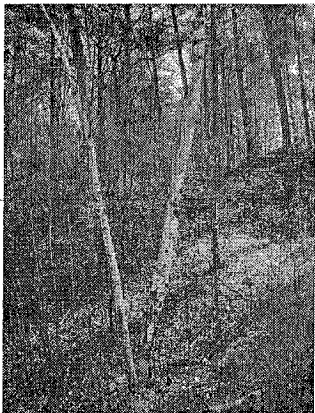
**Rotted Dead Birch Tree
With Apparent Lean Towards The Rear Area Of
The Risk Roof**

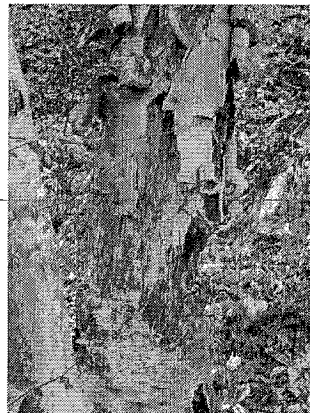
**Base Rotted Area Of Birch
Tree**

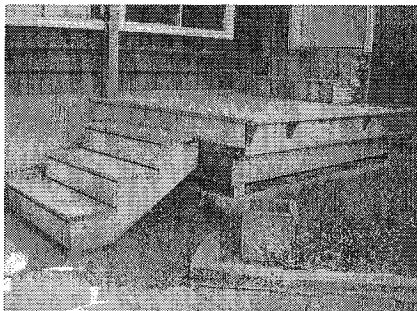
**Missing Hand &
Guard Rail**

A proper railing should be installed on the front porch to prevent personal injury caused by a fall. - Code: L3

A proper guardrail should be added if deck or porch is missing one and is above 24 inches. - Code: L6

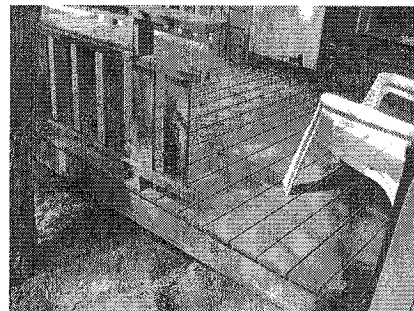
Loose Guard Rail

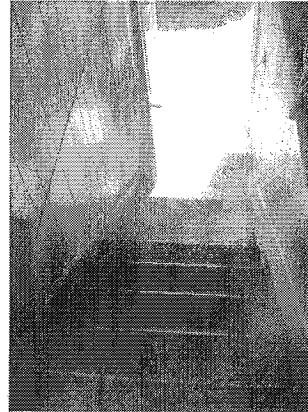
Comments: The interior staircase to the bunk area of the building requires a handrail.

**Missing Handrail Stairs To
Bunk Area**

A proper railing should be added to interior steps where there are 3 or more risers. - Code: L4
