Re: Policy Number: 3954484
Insurance Company: Economical

Property Inspection Report

! Insured Name:	BARRY AND DEBORAH FRIEDMAN		
! Address Inspected:	1037 OAK LANE SOUTH SHARBOT LAKE, ON K0H 2P0		
! Policy # or Binder #:	3954484	! Insurer:	Economical Insurance
! Broker Name:	CARLETON INSURANCE BROKERS	! Broker Number:	57501
! Interviewed:	Barry Friedman		
! Date Inspected:	05/05/2012		
! Inspected By:	Doug Smyth	! Office:	Ottawa Click to find Office
! Current Coverage:	202000		
! Revised Coverage:	279743		
! Variance:	38.49%		
High Value:	<input type="radio"/> Yes <input checked="" type="radio"/> No Change Value

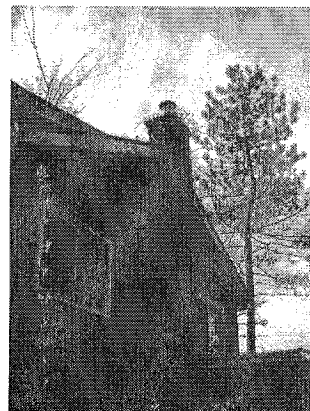
Basement Woodstove
Chimney

Type: Woodstove
Fuel: Wood
Year of Manufacture: Unknown
Condition: See Comments
Comments: The installation of the Haughs S-170 woodstove located in the basement appears to meet all code installation requirements.
Comments:

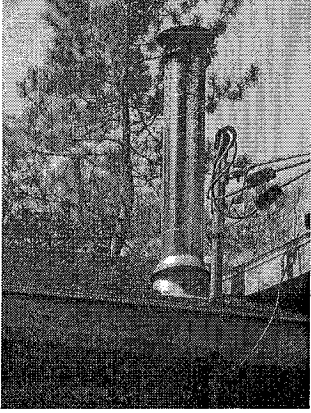
Main Level Woodstove
Chimney

Type: Woodstove
Fuel: Wood
Year of Manufacture: Unknown
Condition: See Comments
Comments: The installation of the Pacific Energy Super Series woodstove located on the main level appears to meet all code installation requirements.

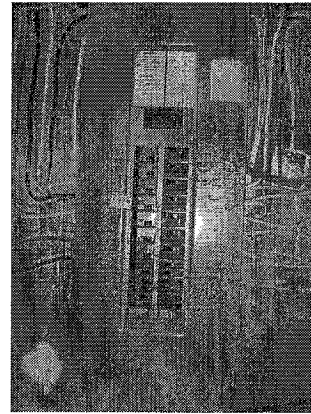
! Electrical Services: 200 amp
! Wiring Type: Romex
! Electrical Panel Type: Breakers
! Over Fused: N/A
! Year of Updates: 2001
! Condition: See Comments
! Comments: See recommendations
Comments:
